# Manhole Inspection Summary

Manhole # S29G\_\_042MH

Insp Date: **4/1/09 1:55 PM**

**Location** Address: **BALTIMORE ST**

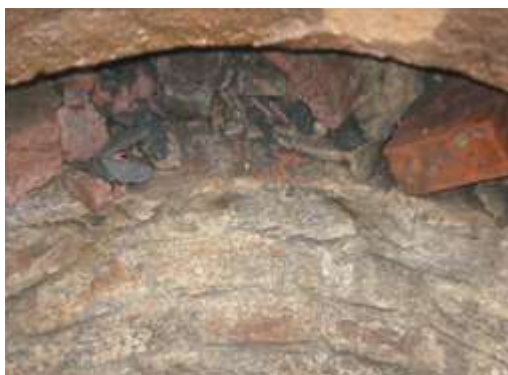
Defect 3

Condition: ☐ Sound ☒ **Cracked** ☐ Root Intrusion ☒ **Loose Brick** ☒ **Deteriorated**

Infiltration: ☐ None ☐ Joint ☒ **Cracks** ☐ Mortar ☐ Roots ☒ **Wall**

Cracks, Loose Bricks and Deterioration in Chimney. CHimney Infiltration

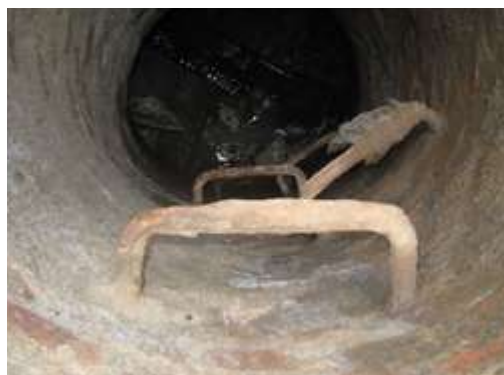
Defect 5

Count: **7** Missing: **0** ☒ **Corroded**

CORRODED RUNGS

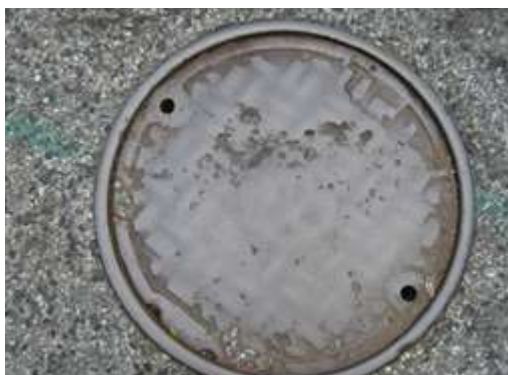
Defect 4

Condition: **Worn**

WORN LID

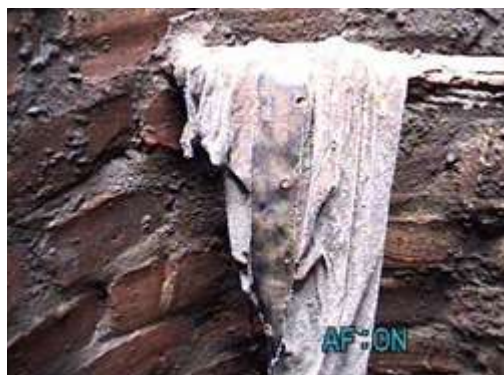
Defect 2

☒ **Evidence Of Surcharge** Depth: **8** (ft.) ☐ Active Surcharge Present

EVIDENCE OF SURCHARGE

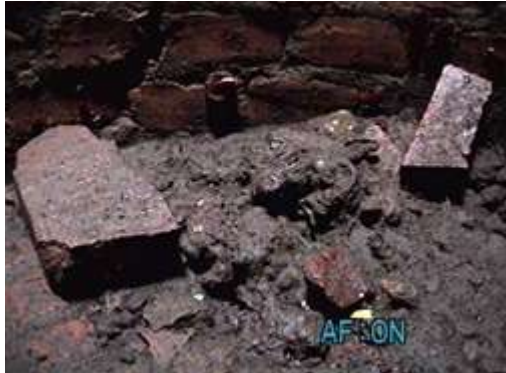
### Defect 1

Condition: ☐ Sound ☐ Cracked ☐ Root Intrusion ☐ Deteriorated ☐ Leaks ☒ **Debris**

DEBRIS ON BENCH

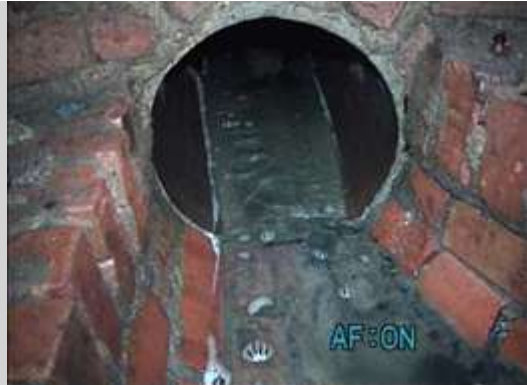
12 O'Clock Outflow

Pipe Height: **8.4** (in.) Rod and Bar (Angled)  
Pipe Material: **Clay** ☐ Pipe Lined  
Invert Depth: **12.16** (ft.) Flow Characteristics: **Slow**  
Deposits: ☒ None ☐ Mud ☐ Sludge ☐ Debris ☐ Grease  
Silt Depth: **4** (in.) Deposits Extent: **Medium**  
Infiltration: **None** Pipe Seal Cond: **Sound**
